## Asset Integrity Case Study: Catalytic Reformer Support Structure

MARCH | APRIL 2022

# Asset Integrity Case Study: Catalytic Reformer Support Structure

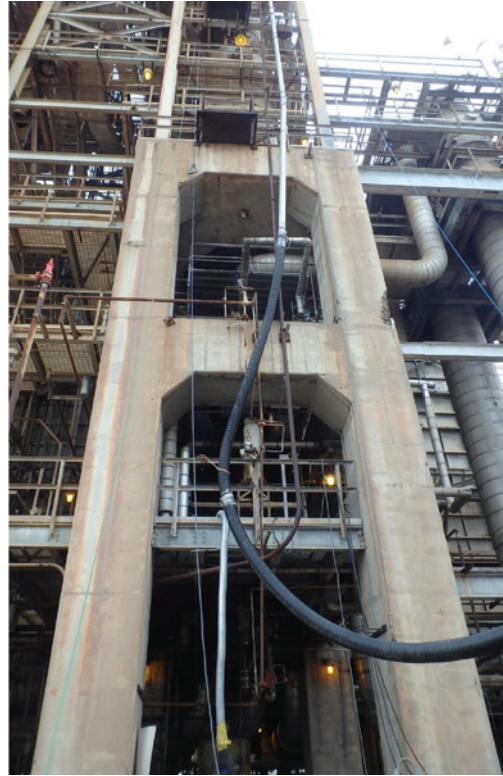
The catalytic reformer support structure shown in **Figure 1** is a conventionally reinforced cast-in-place concrete tabletop originally constructed in 1978 that supports a catalytic reformer, or platformer, and associated steel framing in a refinery on the Gulf Coast. The concrete tabletop consists of a 4.25 ft (1.3 m) thick upper deck that measures approximately 26 ft (8 m) by 18 ft (5.5 m). The upper deck has an octagonal penetration that allows the bottom head of the catalytic reformer and associated piping to pass through the deck as depicted in **Figure 2**. Four square conventionally reinforced concrete columns span from the mat foundation to the upper deck.

Figure 1. Catalytic reformer support structure.

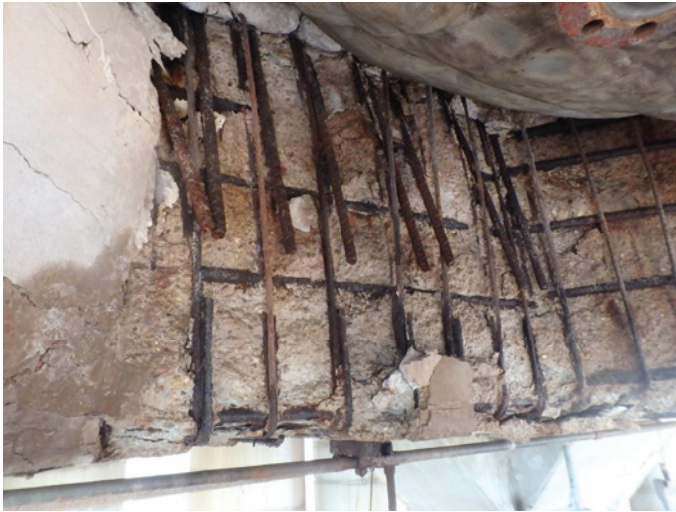
exposed reinforcing and delamination of the sides of the octagonal penetration in the upper deck and along the bottom of the upper deck as shown in **Figure 3**. The original concrete cover was detailed at 3-inch (75 mm) clear; however, in half of the faces, the

**Figure 3.** Spalled concrete with exposed reinforcing on the sides of the octagonal penetration in the upper deck (fractured stirrups are visible).

concrete cover was found to be approximately 4-1/2 inches (115 mm). Widespread cracking and delaminations in the top of the upper deck were also identified shown in **Figure 4**. Even with the deeper concrete cover, corrosion of reinforcing steel was present throughout the sides of the octagonal penetration in the upper deck. Despite the amount of corrosion product observed on the reinforcing bars, the section loss measured on the primary reinforcing bars was generally minor after removing the corrosion product. The most significant finding regarding the exposed reinforcing steel was that many of the No. 5 (5/8-inch [16 mm]) bar stirrups were fractured at the top corner bends. Stirrups are shear reinforcing for the concrete deck—without which, a shear overloading of the deck may result in a brittle failure.

Through the findings of the condition assessment, it was concluded that heat-related deterioration of the concrete and

chloride-induced corrosion significantly accelerated by the heat were the primary causes of the distress conditions. While the support structure had adequate structural capacity to support in-service loads, repairs were recommended during the next major turnaround as unmitigated corrosion and heat deterioration would continue to occur, potentially endangering personnel working the vicinity and ultimately the mechanical integrity of the platformer vessel itself.

The repairs consisted of partial depth concrete repairs with distributed galvanic anodes on the sides of the octagonal penetration and the bottom of the upper deck and required the removal of deteriorated and unsound concrete, and preparation of the concrete substrate to a CSP 7 [4]. Refinery policies prevented the use of abrasive media blasting; as such, all exposed reinforcing was required to be power tool cleaned and meet the requirements of SSPC SP 3 [5]. The fractured stirrups were supplemented with new lapped reinforcing steel. Welded wire reinforcing was detailed as skin reinforcing on the outside of the galvanic anodes to control crack widths on the exposed faces. Cathodic protection was detailed with eight unique zones so refinery personnel could monitor the performance of the system.

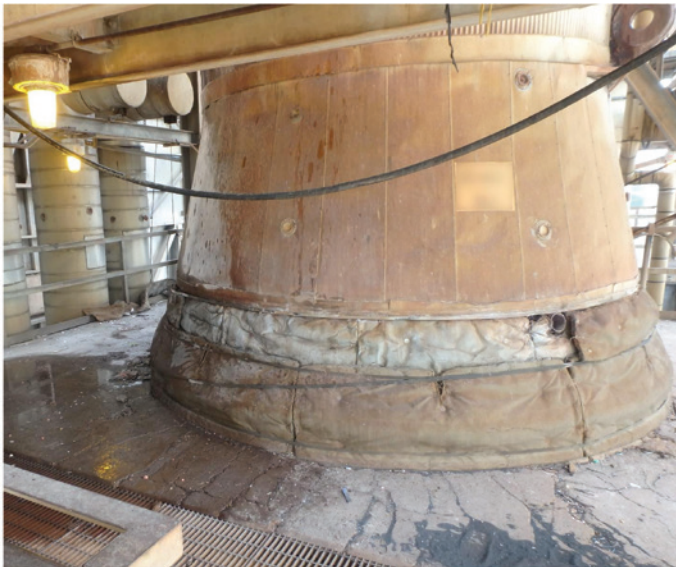
**Figure 4.** Widespread cracking on top of upper deck, typically emanating radially from the catalytic reformer.

The repairs also included partial depth concrete repairs on the top of the upper deck. Localized partial depth concrete repairs were also detailed at specific locations on the columns and beams below the upper deck.

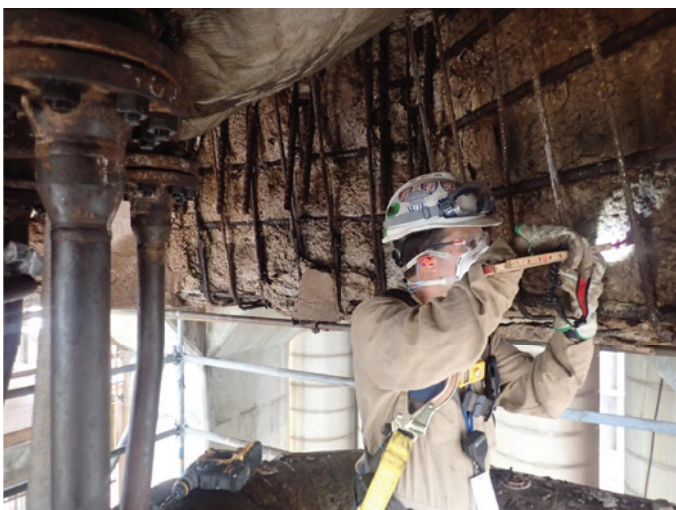
**Figure 5.** Measuring depth of drilled hole used for chloride and carbonation testing.

Discrete concrete hole drilling shown in **Figure 5** was also performed for carbonation and chloride testing. Carbonation testing was performed by applying a pH indicator (phenolphthalein) after cleaning the drilled hole and observing the color profile. At each of four test locations, powder was recovered as the hole was drilled, which was analyzed for the acid-soluble chloride content in general accordance with ASTM C1152, *Standard Test Method for Acid-Soluble Chloride in Mortar and Concrete* [1]. The carbonation testing revealed that the depth of carbonation was minimal and ranged from 1/8 to 1/4-inch (3 to 6 mm). The acid-soluble chloride concentrations for the samples retrieved within the octagonal penetration of the upper deck were between 0.15 and 0.24 % by mass of sample. The original mix design for the concrete sampled was unknown; however, for an assumed cementitious content of 564 lbs per cubic yard (6 sack), an accepted chloride threshold for high risk of corrosion initiation of mild reinforcing steel is 0.09 % - (0.5 to 0.6 % by weight of cement) [2]. The chloride concentrations from the samples retrieved from the upper deck were well in excess of values expected to initiate corrosion.

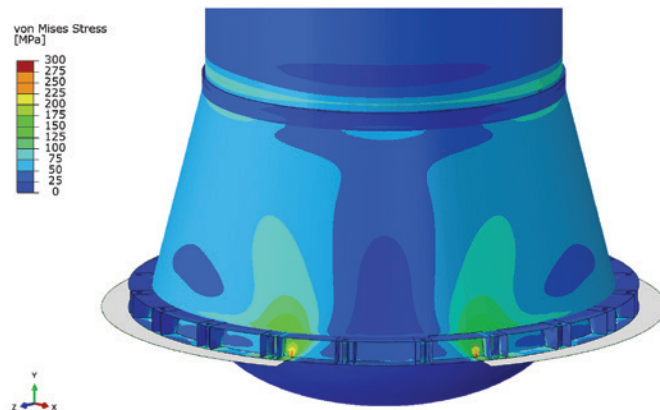
During construction, it was determined that the extent of deteriorated concrete in the upper deck was greater than anticipated, requiring the removal of concrete beyond what was planned, including directly below the catalytic reformer skirt base ring. The removal of concrete below the catalytic reformer skirt base ring would result in the skirt not being directly supported

Figure 6. Image from detailed finite element model used to assess catalytic reformer vessel and skirt during concrete removal.

continuously around the base as designed. To address this issue, the construction sequence was modified to occur in two phases with each phase repairing four nonadjacent zones of the upper deck at a time. A detailed finite element analysis (FEA) of the catalytic reformer vessel, skirt, and base ring (Figure 6) was performed per the Level 3 procedures in API 579-1/ASME FFS-1, *Fitness-for-Service*, to ensure mechanical integrity and stability of the reformer during the repair procedure [6]. This sequencing allowed the additional deteriorated concrete to be removed, which resulted in a high-quality concrete repair while still meeting the demanding project schedule.

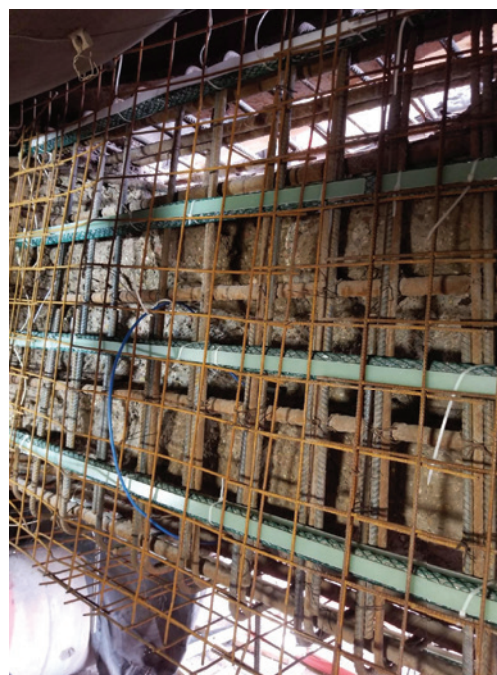
Figure 7. Welded wire reinforcing, galvanic anodes (arrows), and concrete maturity meter in repair area.

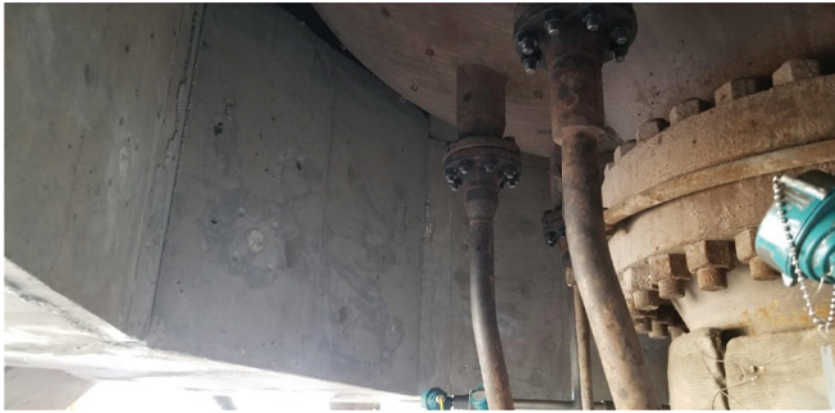
**Figure 8.** Completed repair on the sides of the octagonal penetration in the upper deck.

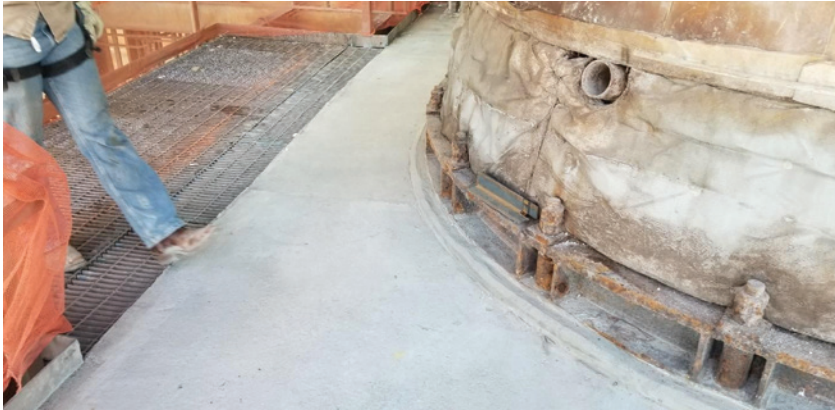
**Figure 9.** Completed repair on top of upper deck.
