## Investigation of Staining of Newly Coated Steel Framing

**STEPHEN W. FOSTER**, Wiss, Janney, Elstner Associates, Inc., Austin, Texas, USA

*Reddish-brown staining appeared on pre-primed steel framing members soon after the application of the topcoat. Despite the primer manufacturer's early hypothesis that surfactant leaching of the topcoat may have been the cause, field and laboratory investigations indicated that water-soluble corrosion products were being mobilized and deposited on the surface due to the presence of moisture. Pre-primed steel delivered to jobsites can begin to rust before receiving the topcoat. Areas of latent corrosion where the primer thickness was low, along with the framing that had been stored outdoors, likely led to corrosion staining after topcoat application.*

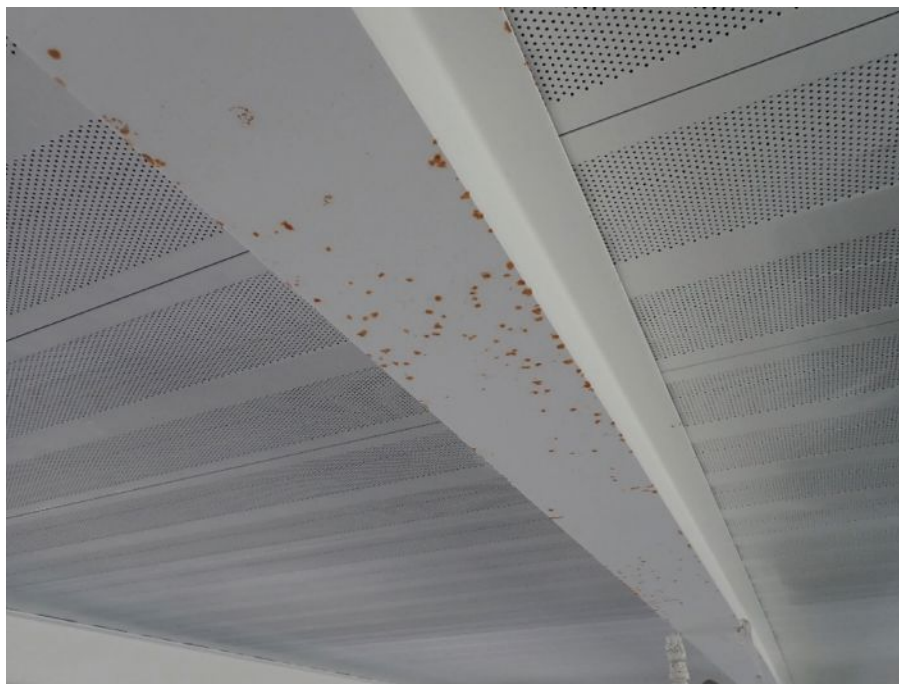
**Newly installed structural steel framing** of the ceiling of a commercial construction project was exhibiting reddish-brown staining of the coating system soon after application of the topcoat, as shown in Figure 1.

**FIGURE 1** Representative steel framing member exhibiting staining of the topcoat.

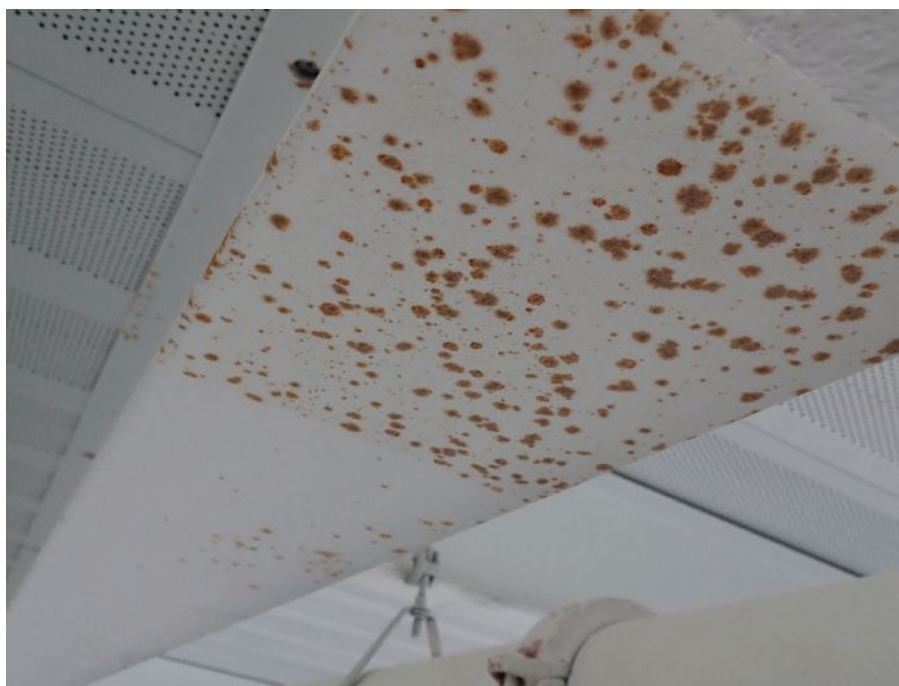
Areas of reddish-brown staining and localized damage to the primer were common at uncoated bottom flanges and edges of the top flanges. This staining was observed at several topcoated areas, and approximately half of the framing appeared to have some degree of staining. When present, most staining was concentrated at the bottom flanges, near edges, or near crevices of member connections. Webs of beams typically did not include staining. However, the bottom of the bottom flanges of some members exhibited distinct, well-defined areas with a medium-dense population of stains, which can be observed in Figure 2.

**FIGURE 2** Representative area of medium-dense staining at bottom flange.

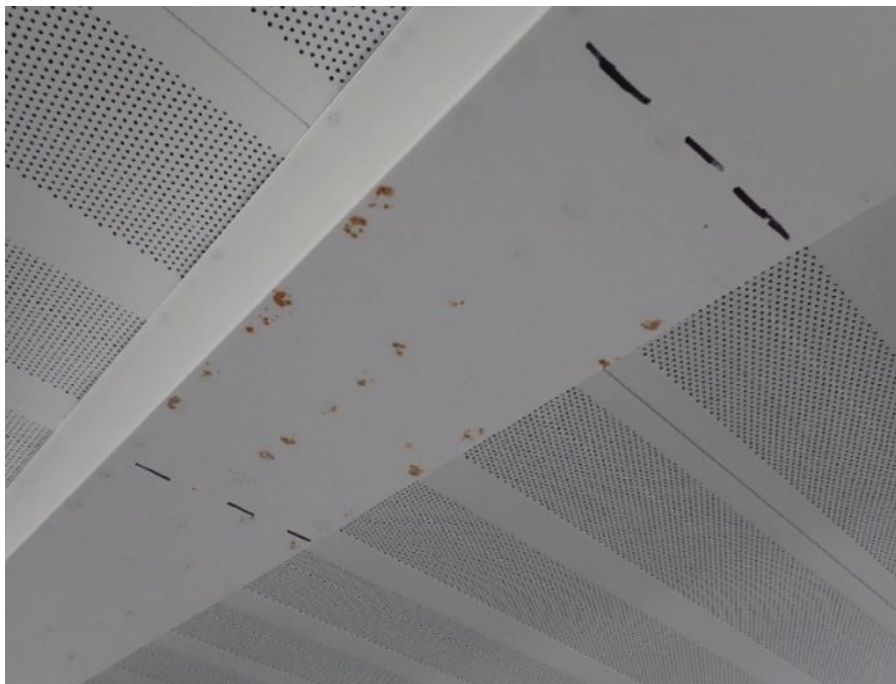
ture was introduced to the coating along the bottom flange at an area with and without staining. A paper towel wetted with distilled water was placed onto the bottom surface of the bottom flanges and covered with a plastic sheet taped to the flanges. After a 24-hour dwell-period, the wet paper towel was removed, and the surface of the coated flanges was observed. The area without prior staining exhibited minor brown stains near the edges of the bottom flange and one stain near the middle of the bottom flange. The stains at the area with prior staining became more pronounced, having turned noticeably darker, which is reflected in Figure 3. Moreover, the stains had leached onto the moist paper towel, which was collected for laboratory testing.

**FIGURE 3** Staining after moisture testing.

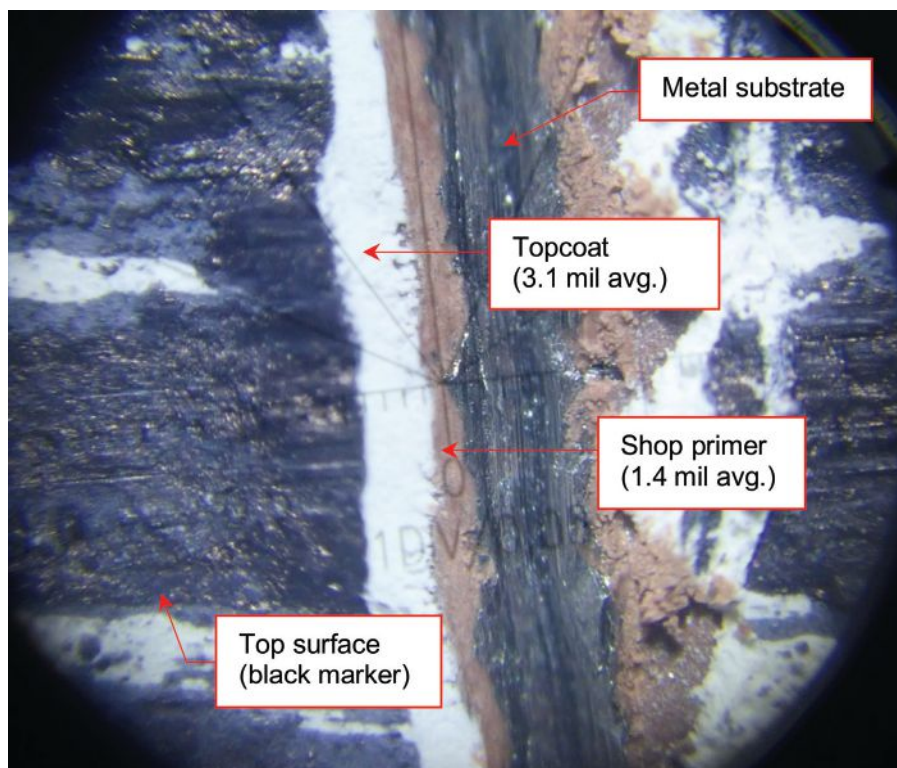
Nondestructive measurements were also performed using a magnetic thickness gauge. At each selected element, a total of four 25.8-square-centimeter (4-square-in) spots were selected on each surface, and five measurements were performed at each spot location for a total of 20 spot measurements. Table 1 summarizes the minimum, maximum, and average thicknesses. A representative paint inspection gage reading is illustrated in Figure 4.

**FIGURE 4** Representative measurement at stained area of bottom flange.

The shop primer application did not meet the specified minimum thickness of 76 microns (3.0 mils) in several areas. Average thickness measurements for the shop-applied primer were consistently below the required minimum in regions where staining was present at the coating. The primer thickness at the underside of the bottom flanges was consistently less than the primer thickness at the webs, which is reflected in Table 1. At the moisture testing location, results clearly indicated lower primer thickness at the area with staining

(approximately 35 microns or 1.4 mils) compared to areas without staining (approximately 89 microns or 3.5 mils). The field-applied topcoat typically met the minimum specified thickness. In many cases, the topcoat thickness was more than double the amount required.

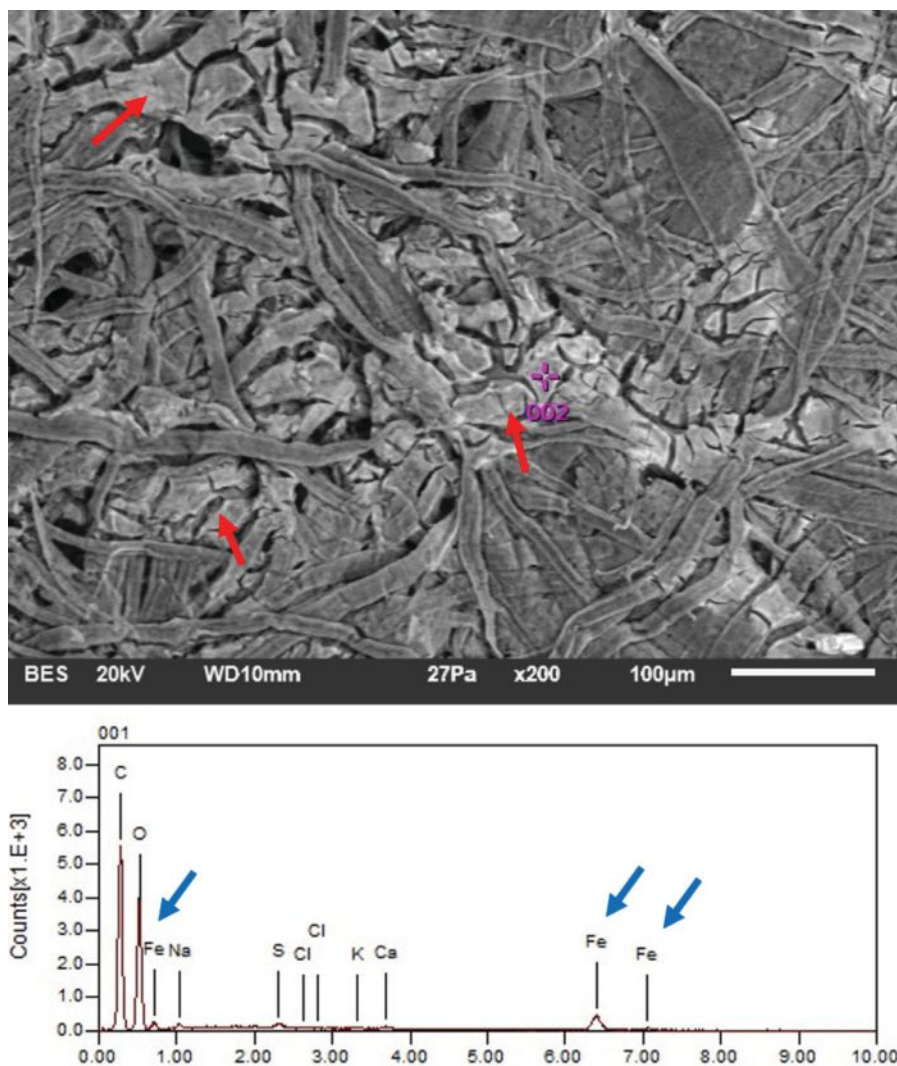
areas of the staining of both Samples 1 and 3, as reflected in Figure 5. However, iron was not detected on the unstained areas of the paper towel of these samples. Additionally, SEM/EDS analysis of control sample C2, where no

Based on the results of SEM/EDS testing, the staining was most likely attributable to water-soluble corrosion products. The moisture testing results indicate that the observed reddish-brown stains are initiated and exacerbated by the introduction of moisture to the coating system, indicating that a water-soluble substance such as underlying water-soluble rust is being extracted and deposited onto the surface of the coating system as reddish-brown stains. The source of moisture can be from the liquid phase of the topcoat itself during application or later from sources such as condensation as simulated by the wet paper towel used during testing. This staining mechanism would tend to manifest itself in areas where the primer is relatively thin and a less-effective barrier to moisture and migration of rust-solutes, more prone to development of pinholes or sim-

**FIGURE 5** SEM image of Sample 1 taken in area of staining. Red arrows point to some of the stained areas on the paper towel. The spectrum shown in the lower portion of the illustration is an area analysis of the entire image, showing the presence of iron (Fe) peaks at 0.705, 6.398, and 7.057 keV (blue arrows).
