Vibration Mitigation and Sound Testing in SUE Hall at the Field Museum in Chicago

How to settle down your *Tyrannosaurus rex* before you take it out in public: vibration-mitigation design for a 67-million-year-old museum specimen.

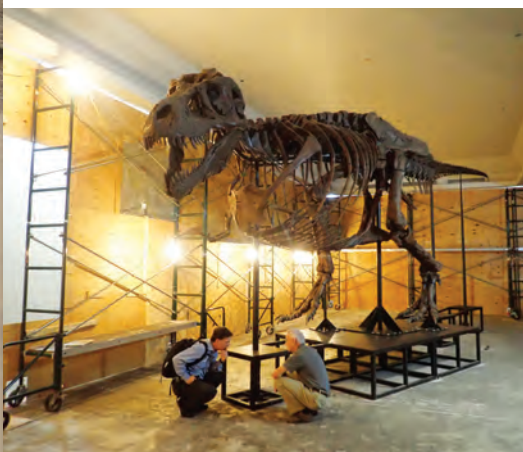
Fig. 2. SUE showing nearly complete reassembly at its new second-floor location when vibration concerns were first identified. Photograph by WJE, 2018.

In February 2018, SUE was dismantled and moved into Hall 25A (SUE Hall). The steel post at the center of the armature was carefully positioned over an existing steel girder. During the remounting, it was noticed that the floor transmitted vibrations much more readily than the floor in Stanley Field Hall. The remounting was on display through a window in the adjacent fossil hall, which attracted crowds of visitors during spring break. On March 30, bone fragments were found on the floor below SUE. The area was carefully examined, and all fragments were collected. The distal section of one of the neck ribs had detached from the armature. It was suspected that vibrations originating from visitors at the viewing window caused the rib to fail. Though the rib was reassembled without any loss of bone, the museum concluded that the floor was too “lively” and needed remediation.

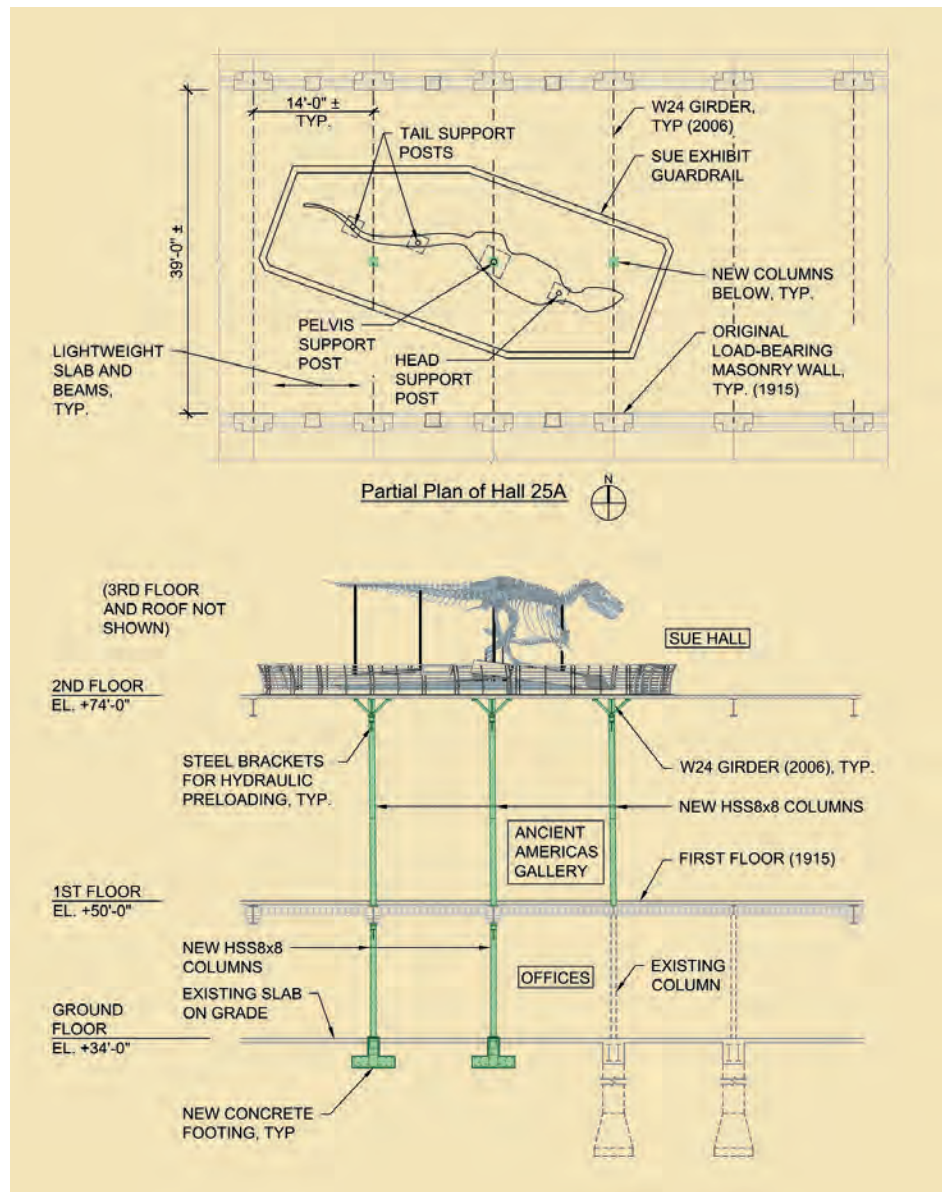
At SUE’s previous location in Stanley Field Hall, the first-floor structure is original to the building; it consists of heavy concrete framing and terra-cotta arches. In contrast, the second-floor structure in SUE Hall (the infill constructed in 2005) consists of a lightweight concrete slab on a metal deck supported by 24-inch-deep steel girders, which span the entire width of the gallery, approximately 39 feet, in between the original load-bearing masonry walls (Figs. 2 and 3).

Fig. 3. Partial plan and section through the new SUE Hall, with new columns and footings shown in green. Drawing by WJE.

Structural review determined that the structure, though sufficient to support the weight of SUE, was susceptible to vibrations because of its long flexible span, relatively lightweight framing, lack of structural continuity, and lack of energy-absorbing (damping) components like partition walls. With the floor's natural frequency of approximately 6 Hz closer to the input frequencies commonly associated with human foot traffic, typically 1.5 to 2.2 Hz, the new location experienced greater dynamic amplification from human activities than the stiffer floor at the previous location. Moreover, the floor vibrations at the new location transmitted readily into the armature base and support posts of SUE since the armature is stiff relative to the floor. Resonant shaking of individual bones occurred where the localized vibration characteristics happened to match or be multiples of the frequency of the floor vibrations.

After weighing all the factors, the Field Museum elected to install three columns below the footprint of SUE, with the columns extending two floors to the ground (see Fig. 3). The multiple walls and exhibit cases in the Ancient Americas gallery on the first floor allowed the columns to be positioned with limited disruption to gallery use.

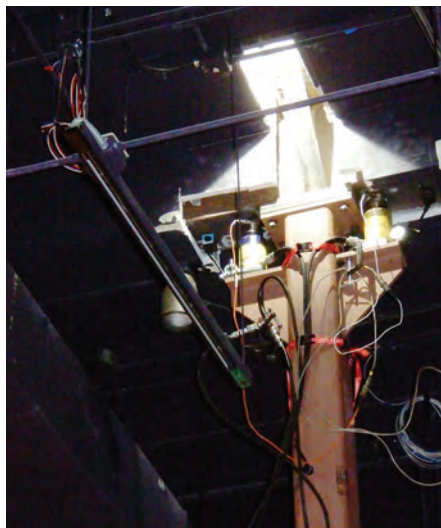
Fig. 4. One of three supplemental columns installed below the existing steel girders of SUE Hall, with hydraulic preloading underway to ensure initial tightness of the system and preloading of the soil below the new spread footings. Photograph by WJE, 2018.

In the late 1800s, the Chicago lakefront had been reclaimed using urban fill, so the soils below the new spread footings in the basement of the museum could prove to be soft and variable. During construction, the exposed soils were tested, and the new columns and spread footings were preloaded using hydraulic rams and digital instrumentation (Fig. 4). This ensured initial tightness of the system and pre-compression of the soils as necessary for effective long-term performance of the retrofit.
