# ASR-Related Distress in Floor Coatings

Reported failures, findings, and testing

by Xiaoqiang (Hugh) Hou, Richard A. Cechner, Terrence M. McGovern, Kevin A. Michols, and Todd Nelson

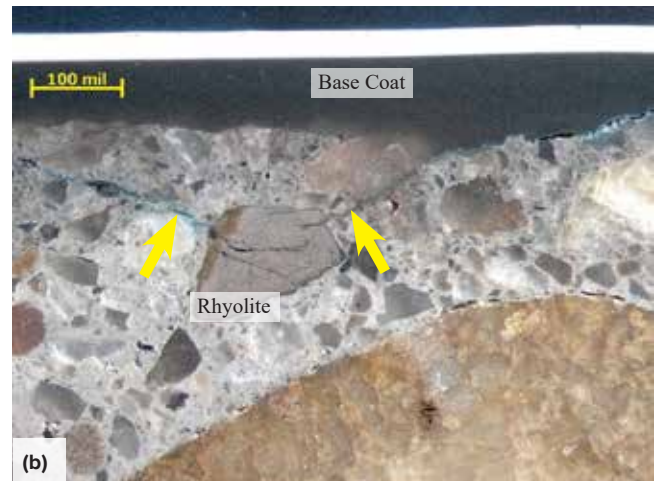
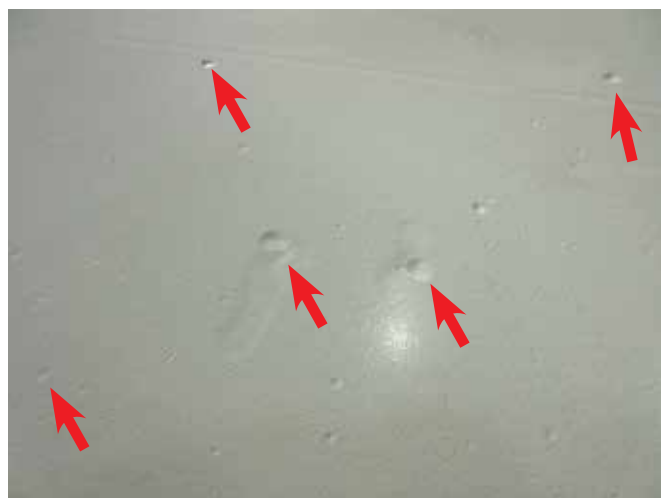
Fig. 2: Blisters in floor coating: (a) larger blisters are marked with red circles; and (b) close-up of a blister cross section showing a rhyolite particle below the blister and cracks emanating from the rhyolite particle (yellow arrows) (Note: 100 mil = 2.5 mm)

We identified ASR of rhyolite, a volcanic rock with high amorphous and microcrystalline silica, to be the culprit of blistering in both cases in Colorado. Rhyolite is an extrusive rock, equivalent to plutonic granite, that is frequently present in the gravel used by producers as coarse aggregate. In the Colorado building that exhibited blistering only in repaired floor areas, we determined that the coarse aggregate in the repair concrete contained rhyolite. We identified ASR of chert

Generally, our investigations revealed a reactive particle (rhyolite or chert) below a blister (Fig. 2(b), 3, and 4), and the size of a surface blister generally correlated with the size and depth of the reactive aggregate particle. Microcracks filled with ASR gel emanated from the affected particles and extended to the concrete surface (shown in Fig. 2(b) and 4). ASR gel was frequently observed at the blister area between the base coat or adhesive of the flooring system and the concrete surface. The near-surface reactive particle occasionally exhibited material loss along the internal cracks due to consumption caused by reactions. Microcracks in the concrete were usually more abundant below and near the blistered area than away from the blister.

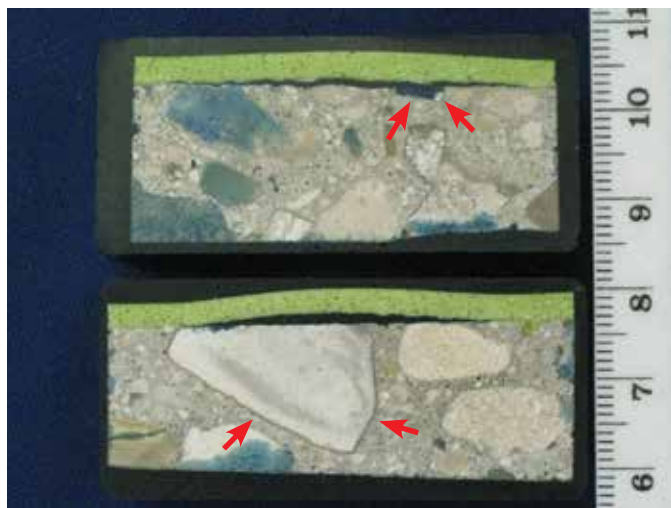
**Fig. 3: Cross sections of floor coating showing blisters and underlying ASR-reactive chert particles (red arrows). Two flooring layers are observed. The base layer is a polymer layer (up to 10 mil [0.3 mm] thick) with white portland cement and small amounts of finely ground limestone. The top layer is a 120 mil (3 mm) thick layer consisting of an organic matrix, portland cement, and sand aggregate**

in fine aggregate as the cause of blistering of the flooring in the Texas building.

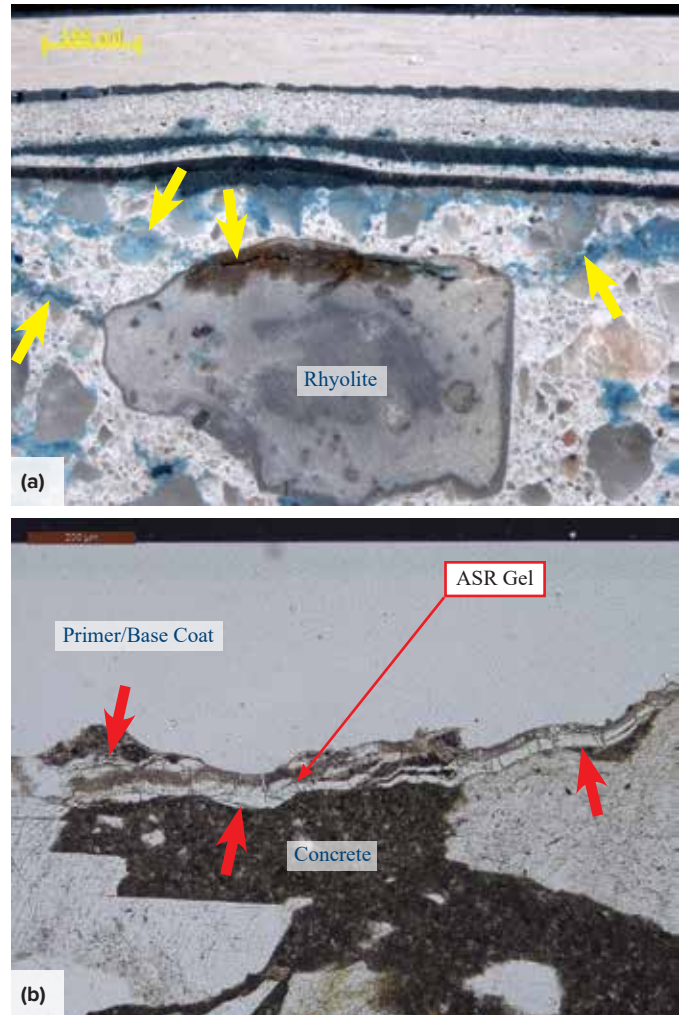
In the two cases involving rhyolite, ASR gel and associated microcracking were also observed in the body of the concrete. Exposed rhyolite particles and nearby paste frequently

**Fig. 4: Rhyolite aggregate: (a) close-up view showing a cracked particle below a blister with emanating cracks (yellow arrows); and (b) thin-section photomicrograph showing ASR gel lines in microcracks (red arrows) (Note: 100 mil = 2.5 mm)**

appeared wet or glossy due to fresh production of ASR gel. In the case involving chert, ASR was observed only in the near-surface region.
