## PROJECT PROFILE

# Roberts Park United Methodist Church

Roof Insurance Claim Consulting | Indianapolis, IN

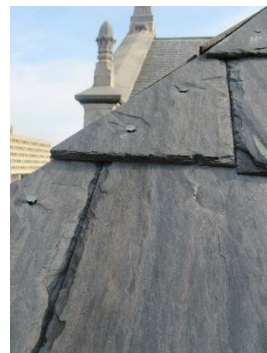
Roberts Park United Methodist Church made an insurance claim for possible wind damage after a number of fallen slate roof tiles were found on the grounds. The insurer of the property performed an investigation and concluded that the damage was not related to wind. Rather, the slate tile roofing was not installed adequately, with insufficient nail lengths. Subsequently, the insurer concluded that the roofing system was not insurable. The Church then retained WJE to review previous investigation reports and independently assess the roofing system.

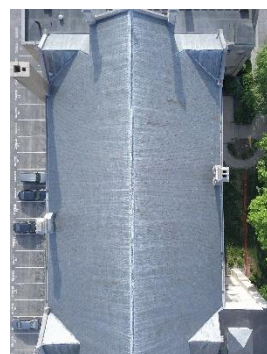
WJE's independent evaluation of the roofing system consisted of reviewing previous design documents and investigation reports as well as a site visit to document the existing condition of the roofing slate tile. WJE also utilized an unmanned aircraft system (UAS) to photographically survey the roof and supplement WJE's visual observations. WJE measured the lengths of the slate tile nails and quantified the number of failed slate tiles. Contrary to previous investigation reports, the nail lengths of the slate tile roofing were sufficient based on industry guidelines and currently adopted building code requirements.

The percentage of broken, missing, or displaced tiles observed was approximately 0.25 percent over the twenty-two-year life of the roof—significantly less than the expected failure rate commonly expected of slate tile roofing systems—1 percent in two years. The quantified percentage of failed tiles was well within the tolerance for what would typically be expected of a slate roof of this age and installation. The cause of the broken, missing, or displaced slate shingles was largely related to natural defects in the slate material, which are expected. As such, the conditions observed were consistent with maintenance items, as opposed to installation-related deficiencies. WJE provided conclusions to the Church to pursue insurance options for the roofing system of the building.
