State Route 2/Interstate 5 Connector

Investigation of Fire Damage | Los Angeles, CA

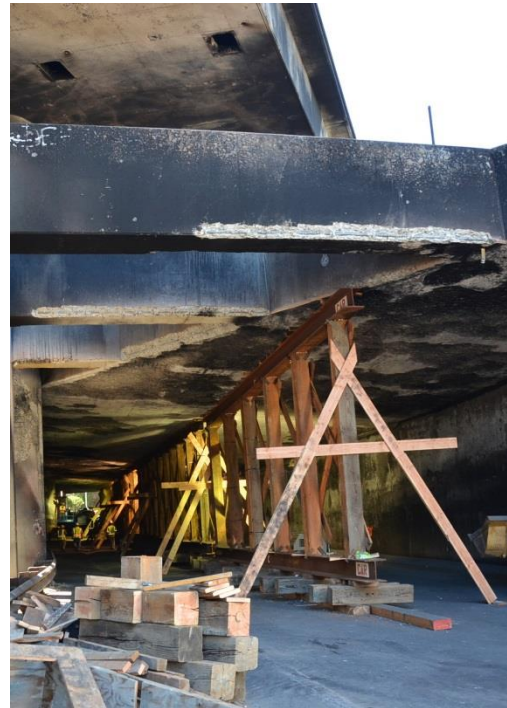
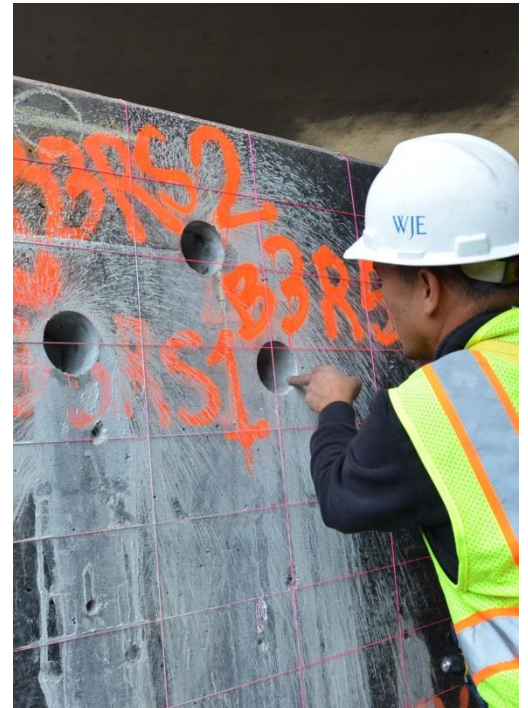
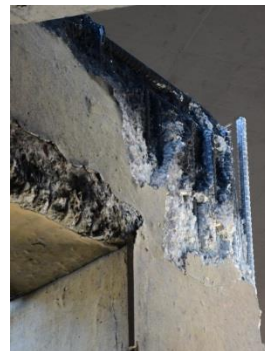
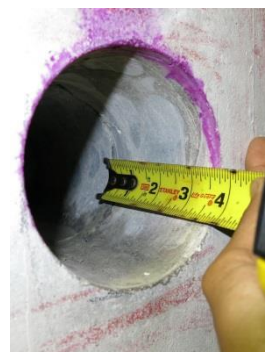
The investigation determined that the walls and soffit of the underpass exhibited significant visible damage from the fire, consisting of spalling up to 4 inches deep. The two columns within the underpass also suffered a significant amount of visible spalling, exposing reinforcing steel at a few areas. IE testing and observations at core holes identified possible delaminations and heat damage. The upper deck had only minor fire damage with small areas of shallow spalling and material damage. However, compressive strength results indicated that the undamaged concrete appeared to significantly exceed the original design strength requirement.

For the areas of damaged concrete, WJE provided general repair recommendations, including removal of damaged concrete by water-blasting or chipping and replacement with a cementitious structural-repair mortar, concrete, or shotcrete, as appropriate.
