# Lessons in Galvanic Cathodic Protection Technology from Soldier Field and the Franklin Avenue Bridge

Arne P. Johnson  
John S. Lawler  
Michael S. Murphy

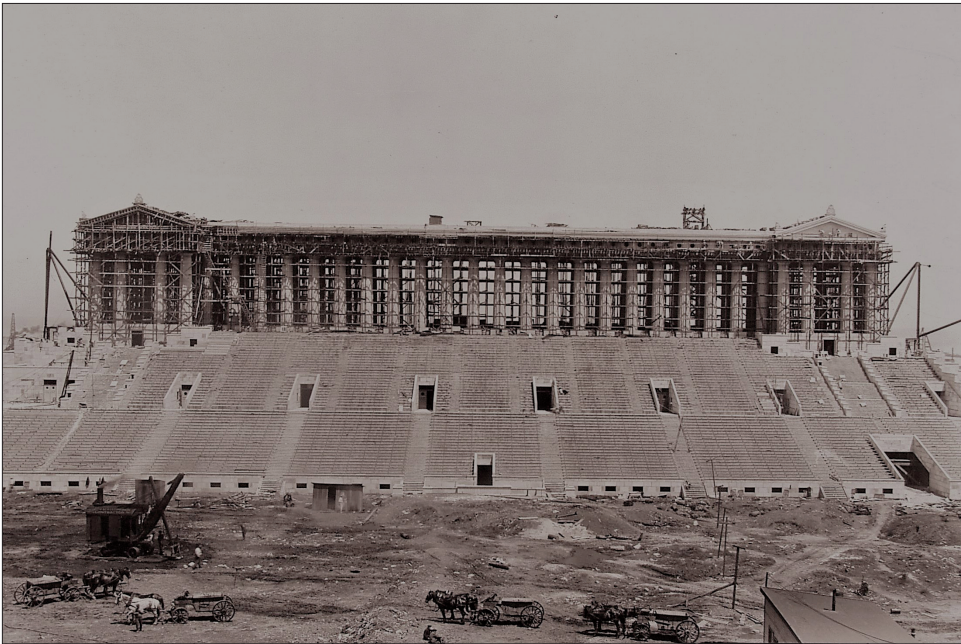
Fig. 3, opposite. Soldier Field, Chicago, Illinois, west grandstand and colonnade during construction in 1924. Image courtesy of the Chicago Park District.

Soldier Field was constructed between 1922 and 1926 in Chicago, Illinois (Fig. 3). The stadium was listed on the National Register of Historic Places in 1984 and designated a National Historic Landmark from 1987 to 2006. Original elements of the structure that remain include the concourses at the stadium perimeter and the east and west colonnades.<sup>4</sup>

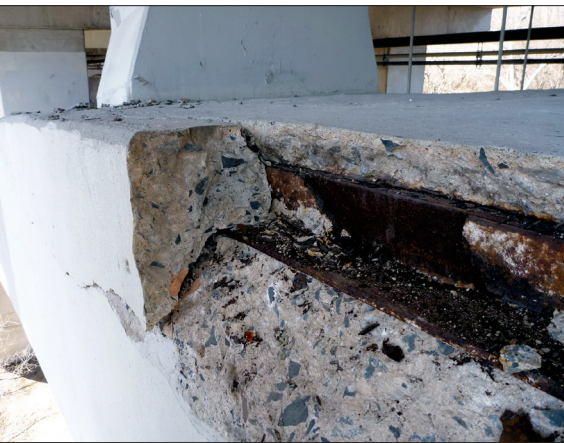
Fig. 7. Franklin Avenue Bridge, example of chloride-induced corrosion spalling along the arch-rib corner, 2012.

The assessments and materials testing identified widespread deterioration in the original concrete caused primarily by chloride-induced corrosion of the reinforcing steel, as well as freeze-thaw deterioration (cracking and eventual disintegration of concrete due to freeze-thaw cycling of saturated, non-air-entrained concrete). In the arches, the most prevalent damage was corrosion-induced cracking and spalling along the arch corners where deicing salts used on the deck had penetrated (Fig. 7). Freeze-thaw damage was also present below leaking deck expansion joints and in the spring-line zones where long-term moisture exposure was most severe.

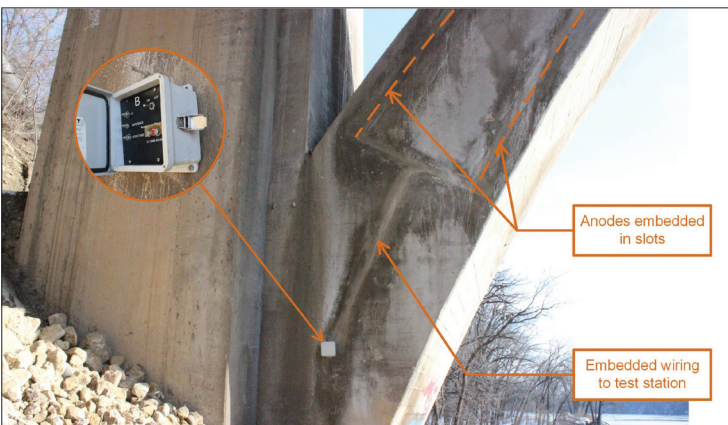
Fig. 9. Franklin Avenue Bridge, example of built-in monitoring station (before surface of concrete was cleaned and coated), 2017.

In this design, current flow along the ionic current path was promoted by the availability of moisture, presence of chloride ions, low-resistivity embedding mortar, and low-resistivity original concrete (when moist). Two permanent built-in monitoring stations were included in the cathodic protection installation, one at each end of the bridge (Fig. 9).
