PROJECT PROFILE

The Art Institute of Chicago Loggias

Restoration Design and Laboratory Testing | Chicago, IL

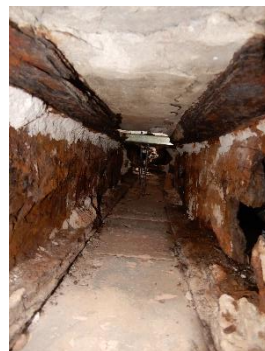
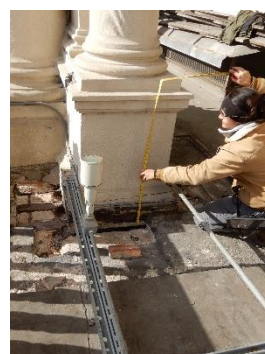
During stone balustrade maintenance at the south loggia, severe corrosion of underlying steel members was discovered. Archival review revealed the corroded elements were circa-1893 triple I-beams supporting a clay tile arch deck and stone facade. Field exploration found that corrosion and section loss from long-term water infiltration extended several feet from the ends of the beams, through a heavily loaded region below a stone plinth. Severe corrosion and section loss were present at twenty total triple I-beam locations among the south and north loggias.

After implementing elevation monitoring and provisional shoring, WJE developed structural repair options. The most straightforward required underside access. However, because the art galleries below the loggias would need to be deinstalled to allow repairs from below, an innovative option was devised to repair from the topside only, thus saving the museum substantial disruption and associated costs.

The topside repair concept entailed removal of the clay tile between the corroded ends of the triple beams without allowing debris to fall into the gallery spaces below and without compromising the thrust in the clay tile arch. Afterward, new reinforced concrete was cast between the triple beams to strengthen them, using the corroded beams as forms. Unlike traditional composite steel-concrete design, the resulting hybrid beams consist of three regions that act like a tube inserted into a tube: (1) in the corroded region, the new reinforced concrete acts alone, (2) in the overlap of the concrete with the uncorroded beams, a force couple between the concrete and existing steel flanges resists the loads, and (3) beyond the overlap, the clay tile infill remains and the original I-beams act alone.

Given the unusual nature of the repair, WJE performed a laboratory mockup and load test to verify the performance and refine the repair details. The innovative design ultimately saved the museum millions of dollars as well as substantial disruption to its art collections. The project received a 2024 Excellence in Structural Engineering Award from SEAOL.
