Penn Circle Apartments

Masonry Facade Assessment and Repair | Carmel, IN

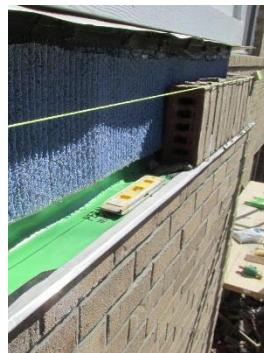
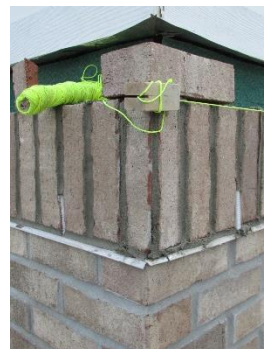
WJE's assessment revealed that many as-built conditions of the facade system did not conform to construction documents, including missing flashing terminations and inadequately installed or missing sealant joints at material interfaces, window perimeters, and expansion joints.

WJE reviewed repair concepts developed by the owner's consultant to address observed conditions and performed field observation services during the repair project as quality assurance for the prospective buyer.
