Vibration Mitigation and Sound Testing in SUE Hall at the Field Museum in Chicago

How to settle down your *Tyrannosaurus rex* before you take it out in public: vibration-mitigation design for a 67-million-year-old museum specimen.

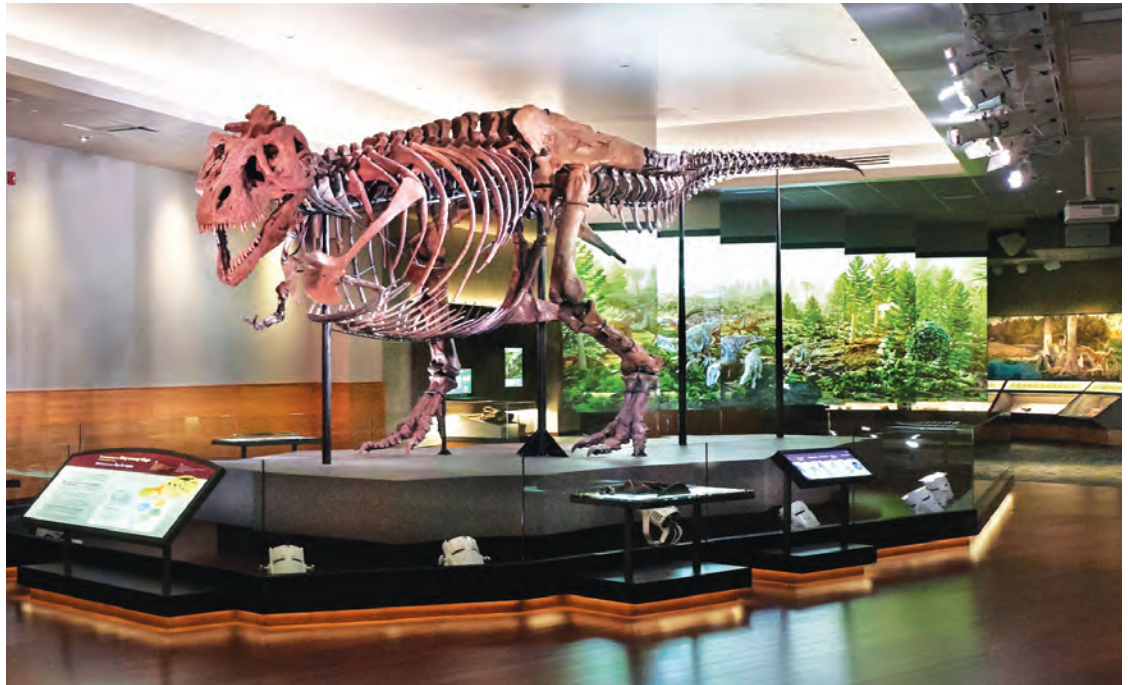
Fig. 1. Completed SUE Hall, Field Museum, Chicago, Illinois, soon after public opening, with sound show and digital animations on glass screens in background. Photograph by John Weinstein, 2018. © Field Museum of Natural History GN92620_092B.
