The IEBC's Roof Diaphragm Evaluation Requirements

When Reroofing Requires a Lateral Analysis

By Dale Statler, P.E., and Jerry Maly, P.E.

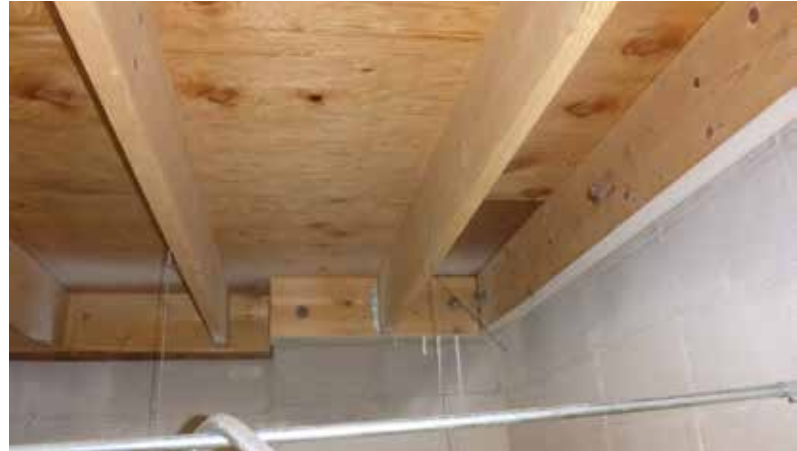
Figure 1. Wood diaphragm connections and shear walls not visible from the top surface of the diaphragm.

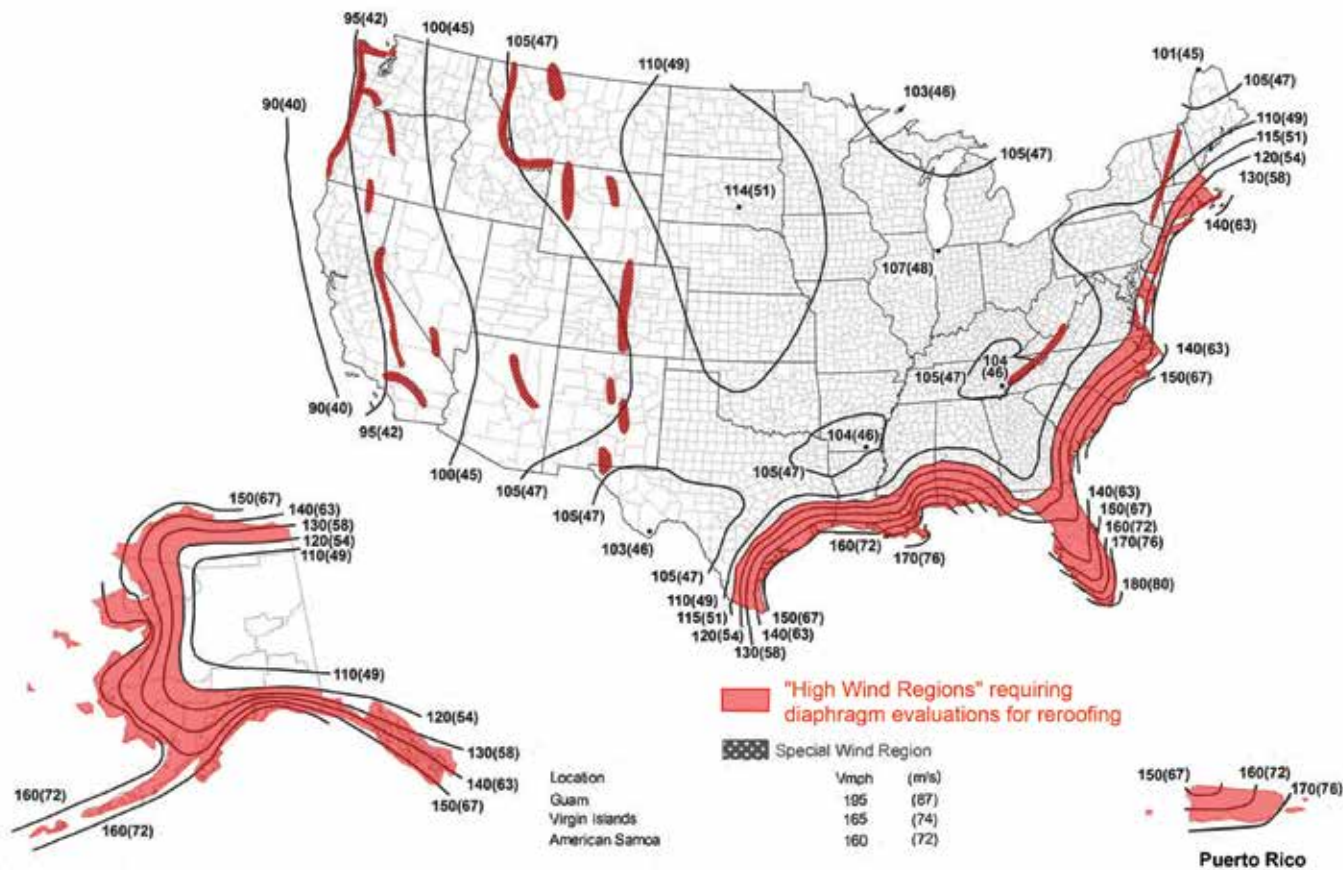
Figure 2. Reproduction of Figure 1609.3(1) annotated from the 2019 International Building Code; Copyright 2017.

See *Figure 2 (page 16)* for the reproduction of 2018 IBC Figure 1609.3(1) with areas conforming to the IEBC definition of “high-wind regions” highlighted.
